Dermal Repair Scaffold

Healing of a Plantar Heel Traumatic Avulsion to Bone with PriMatrix™

Marie A. Shaw, M.D. - Emergency Medicine

Memorial Hermann Northeast Wound Care Center®

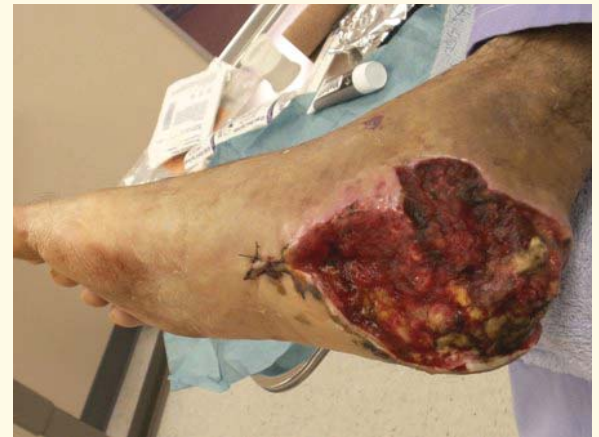
Figure 1. Right heel fat pad and plantar heel skin avulsion to bone.

Upon presentation to the wound care center on 11/09/06, an initial evaluation revealed a large black, necrotic area that extended from the right posterior heel to the instep area that measured 18 cm x 11 cm. Wound depth was not measurable due to eschar. Initial treatment involved a culture of wound exudate after a small incision and debridement (I&D), and MRI. The culture report was negative but the MRI revealed evidence suggestive of osteomyelitis of the right posterior heel area. Antibiotic therapy continued and hyperbarics was initiated on 11/10/06, daily. The patient underwent another I&D and debridement to bone on 11/11/06.

Figure 1 portrays the patient's right heel as of 11/17/06. The patient was unable to off-load due to the location and significant size of the wound. Over the course of the next three months, the patient underwent 26 hyperbaric treatments and other treatment modalities including silver dressing application and application of a living skin equivalent. While the wound did show improvement throughout this course of treatment (Figure 2), progress was slower than anticipated.

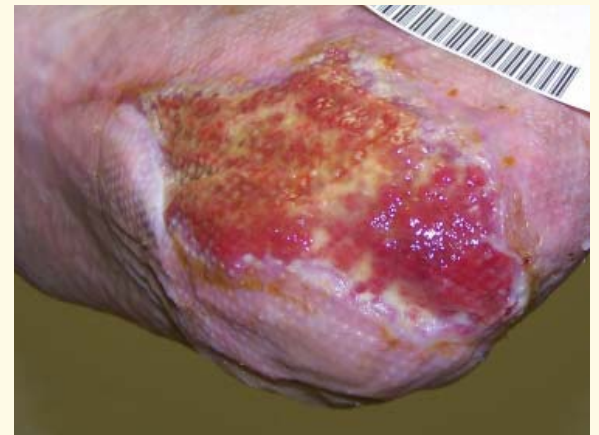
Figure 2. Wound following hyperbaric treatments, application of a living skin equivalent, and other treatment modalities.

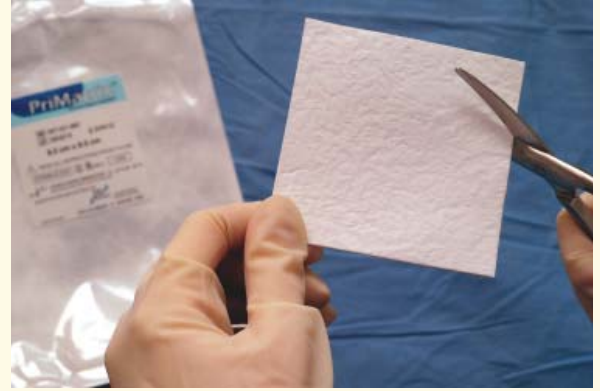
Figure 3. Preparing PriMatrix Dermal Repair Scaffold for application.

PriMatrix™ Dermal Repair Scaffold is an acellular collagen matrix derived from fetal bovine dermis. The treating physician chose to use this product in an effort to speed the patient's recovery time by closing the wound more rapidly. On 02/16/07, an 8 x 8 cm piece of PriMatrix was trimmed to the dimensions of the wound in a dry state. It was then applied to the debrided wound bed and hydrated in place by applying droplets of room temperature saline with a syringe. Complete hydration was achieved within approximately 30 seconds. The product was secured in place using Steri-Strip™ skin closures, covered with a silicone-based contact layer and non-stick dressing pads, and wrapped with gauze bandages.

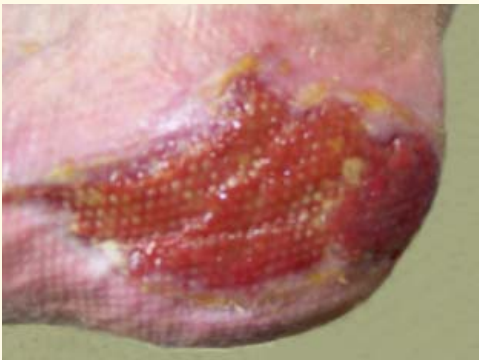
Figure 4. One week prior to the initial application of PriMatrix.

From the first application, rapid reepithelialization was observed. No side effects were noted, such as the brownish slough observed earlier in the treatment process upon application of a living skin equivalent. With each subsequent application of PriMatrix, the dimensions of the wound progressively decreased (Figures 5-8). The wound measurements over the course of treatment are summarized in Table 1, shown to the right. One week after the fifth PriMatrix application, the wound had healed completely, as shown in Figure 9, and the patient was discharged.

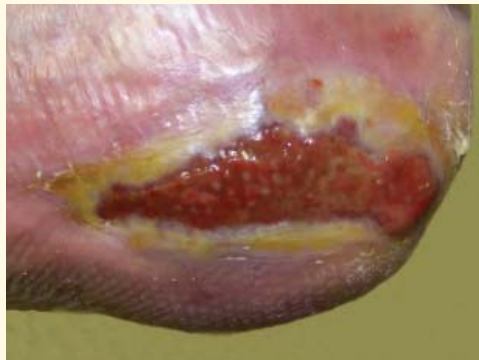
Figure 5. One week after the 2nd PriMatrix application.

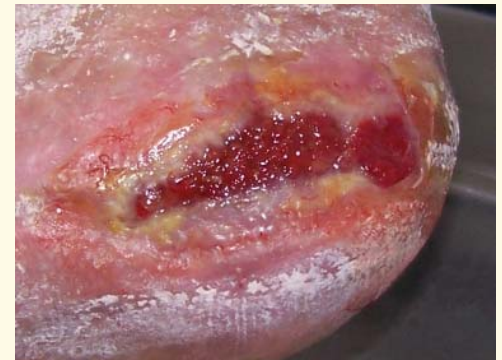
Figure 6. Two weeks after the 2nd PriMatrix application.

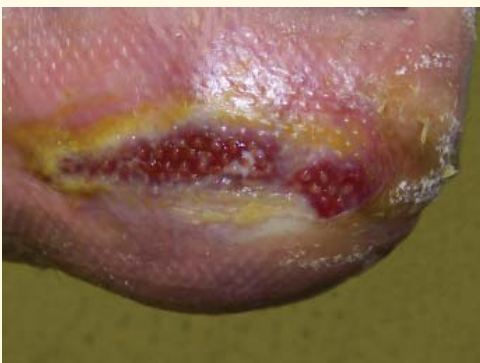
Figure 7. Three weeks after the 2nd PriMatrix application.

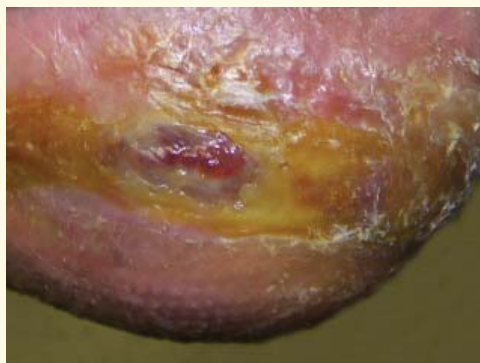
Figure 8. Two weeks after the 3rd PriMatrix application.

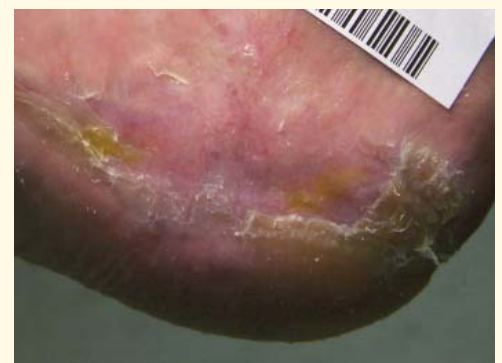
Figure 9. Completely healed wound after the 5th application of PriMatrix.
